## 15.0 Salt Lake City, Utah, Disposal Site

### 15.1 Compliance Summary

The Salt Lake City, Utah, Disposal Site, inspected on April 2, 2007, was in good condition. The disposal cell, its cover materials, and associated surface water drainage features were in excellent condition. Removal of surface soil with historically elevated concentrations of  $\text{Ra}^{226}$  was performed along the property boundary on the east and west sides of the site by EnergySolutions, the adjacent radioactive waste disposal operator. Several radiological waste items found on site from EnergySolutions waste disposal operations were surveyed and determined to be uncontaminated. All surface radiological survey measurements taken on site during the inspection were below DOE Radiation Control (RadCon) Manual limits, indicating that spillover and windblown contamination from the adjacent EnergySolutions radioactive waste disposal operations is currently not an issue.

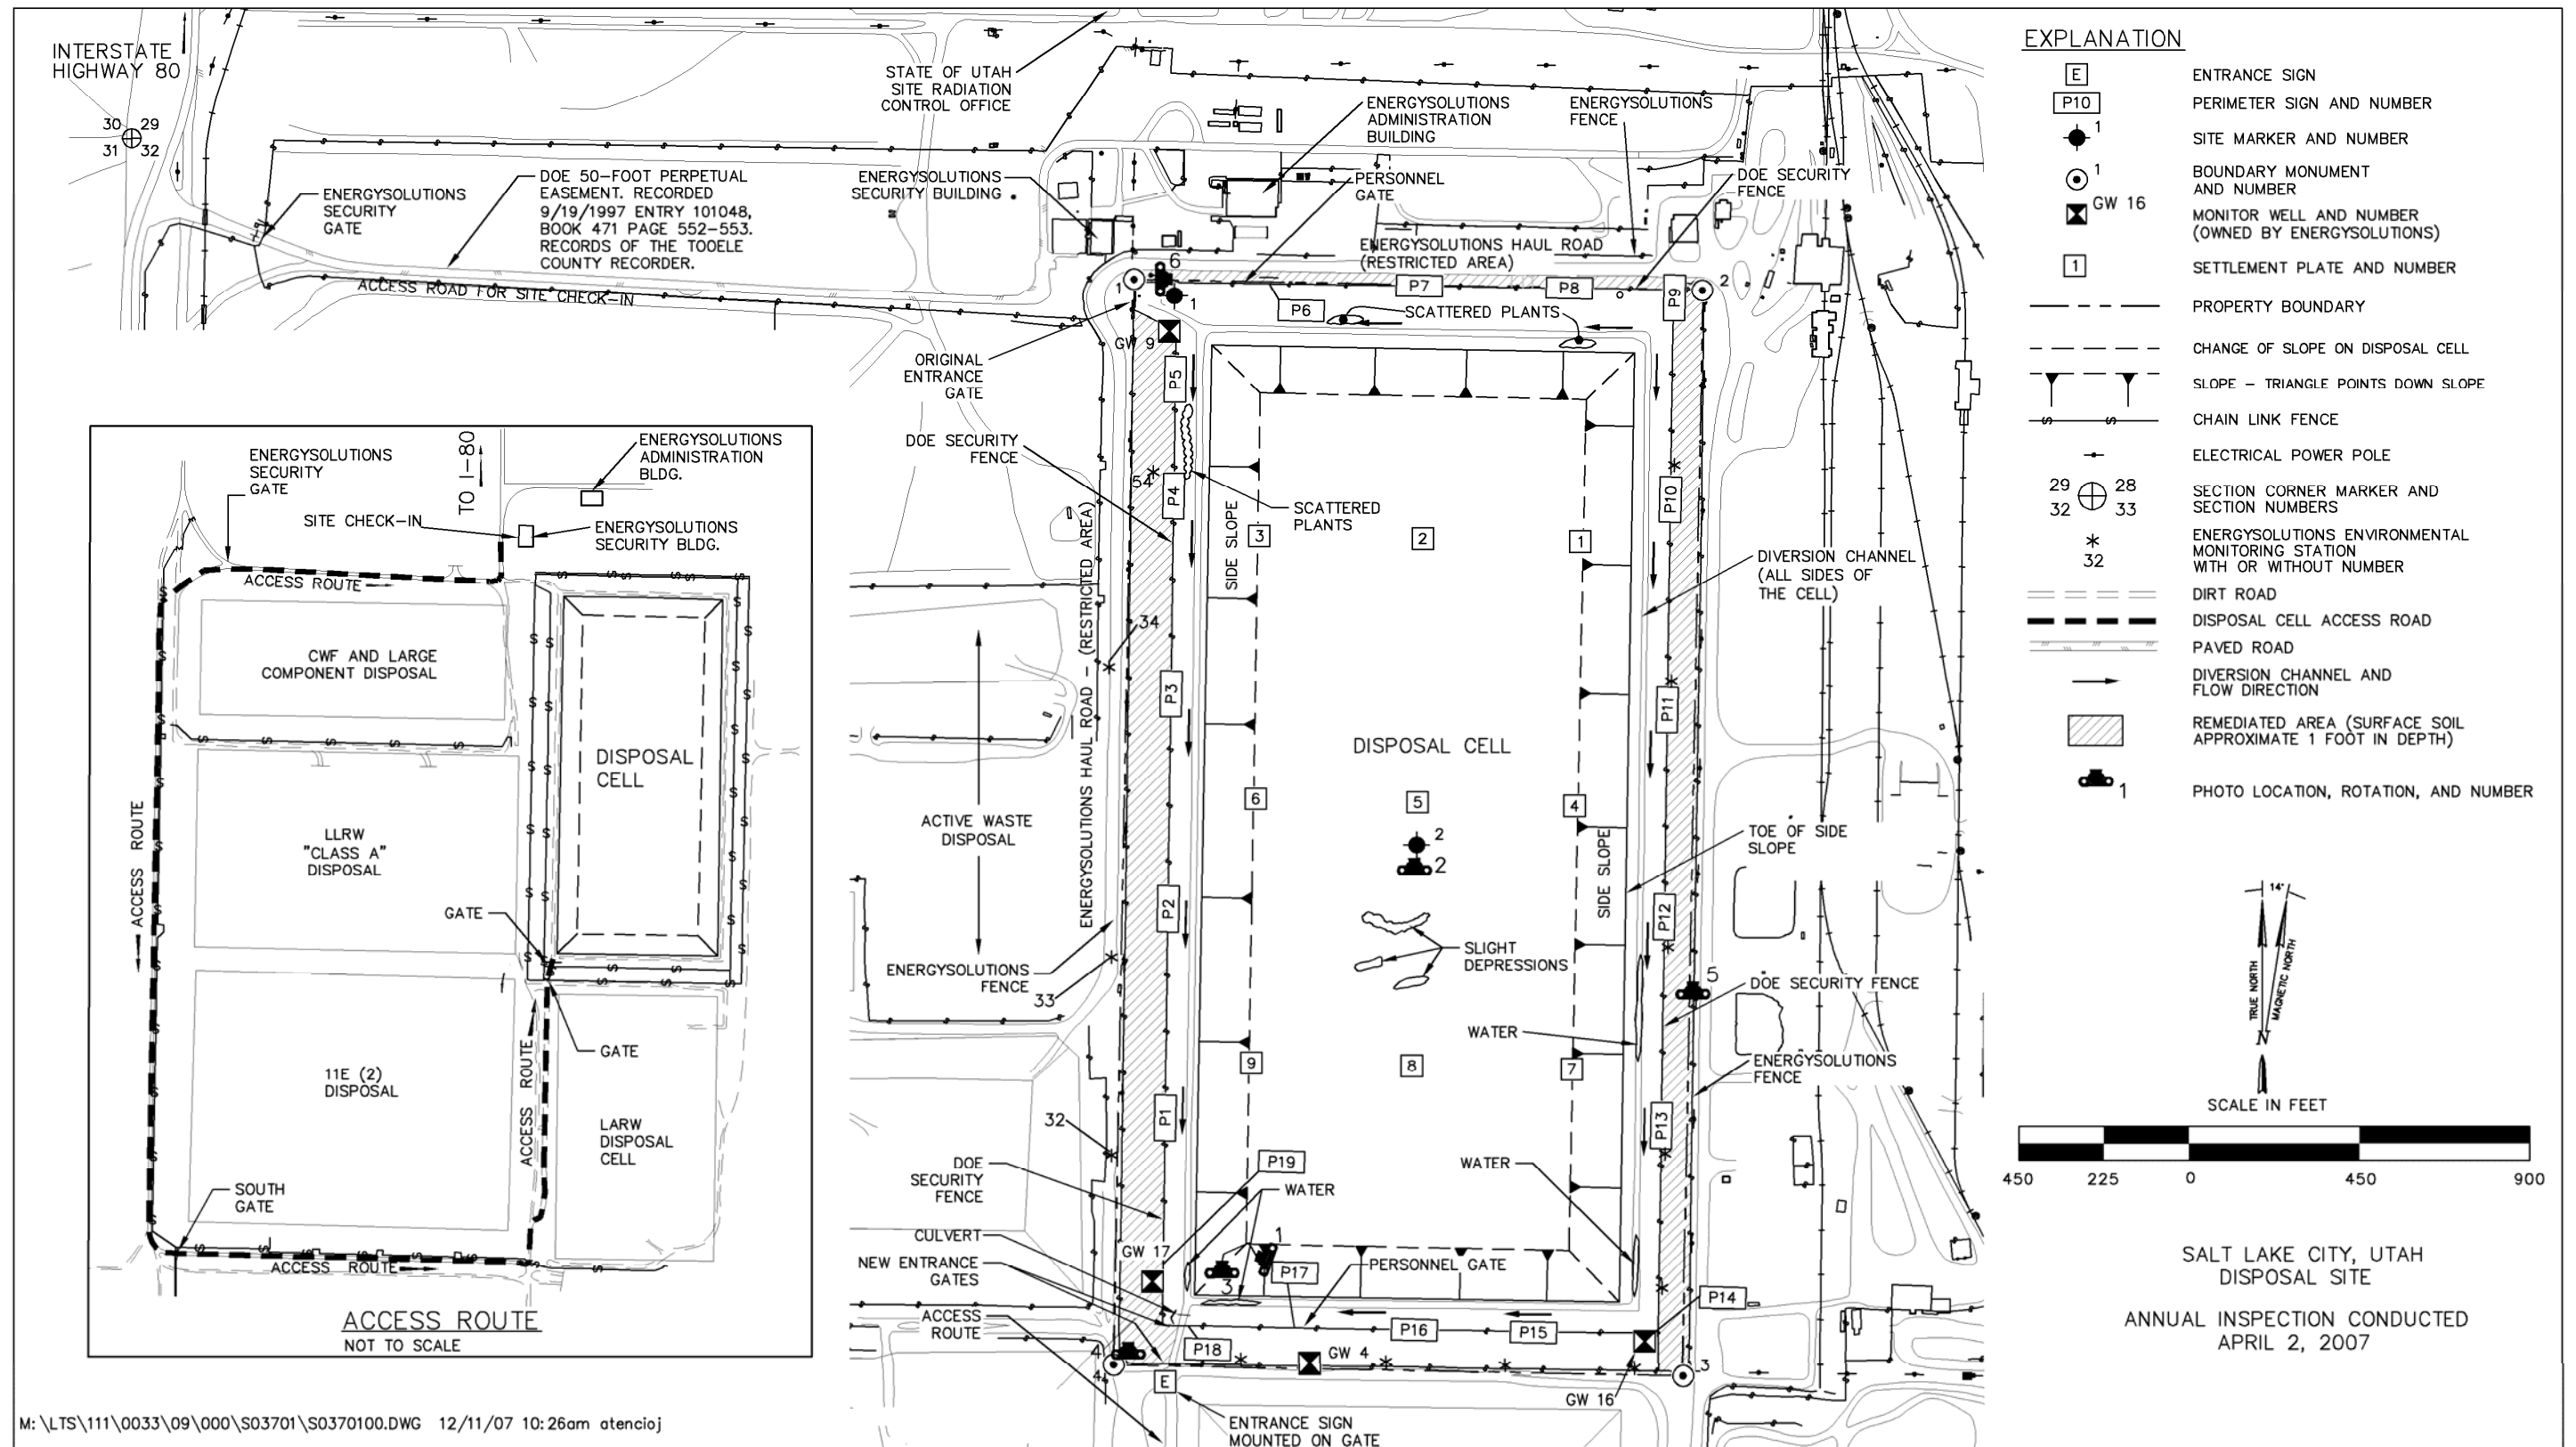
- 15A Access to the site is now along a route to the southwest corner of the property. Due to EnergySolution’s ongoing radioactive waste disposal activities on the surrounding property (PL–1), the adjacent haul roads currently used to access the southwest corner of the DOE site are designated as restricted areas (radiological control areas) and controlled by EnergySolutions. After being briefed by EnergySolutions health and safety personnel on the radiological hazards and controls in place for crossing these restricted areas, inspectors sign a radiological work permit and are issued dosimeters. EnergySolutions personnel then escort the inspectors to the site and accompany them during the inspection.

A chain-link security fence owned and maintained by EnergySolutions is located on the site property boundary on the east, west, and south sides. A second chain-link security fence, owned and maintained by DOE, that surrounds the disposal cell, lies within the EnergySolutions fence on the east, west, and south sides. On the north side is a single chain-link security fence located on the property boundary that is maintained by DOE. EnergySolutions has an additional fence bordering their haul roads directly north and west of the site. All fences were in good condition.
